Manhole Inspection Summary

Manhole # S3500_007MH

Insp Date: **1/24/07 1:10 PM**

Location Address: **2300 BARKLEY ST**

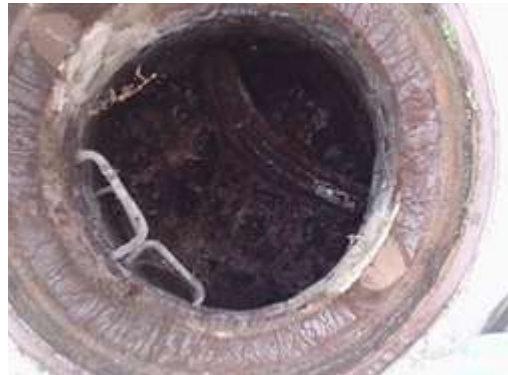
Top View

☐ Parged ☒ **Debris** (not Condition related)

☒ **Evidence Of Surcharge** Depth: **1** (ft.) ☐ Active Surcharge Present

Evidence of surcharge - Bench debris.

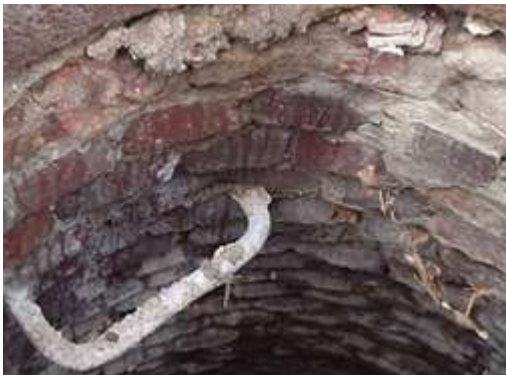
Defect

Condition: ☐ Sound ☐ Cracked ☐ Root Intrusion ☐ Loose Brick ☒ **Deteriorated**

Infiltration: ☐ None ☒ **Joint** ☐ Cracks ☐ Mortar ☐ Roots ☒ **Wall**

Infiltration: ☐ None ☐ Joint ☐ Cracks ☐ Mortar ☐ Roots ☒ **Wall**

Adjustment deterioration and infiltration.
Barrel infiltration.

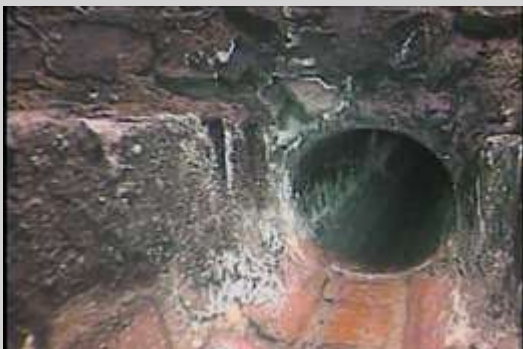
6 in. Circular Gravity Sewer Pipe In @ 4 O'Clock

Deposits: ☐ None ☐ Mud ☐ Sludge ☐ Debris ☒ Grease

Silt Depth: **0** (in.) Deposits Extent: **Light**
